THE REICH CHANCELLERY

A WORK ANALYSIS

THE ENTRANCE HALL

New Reich Chancellery/ Interior/ Voßstraße 5/ 1937-1950

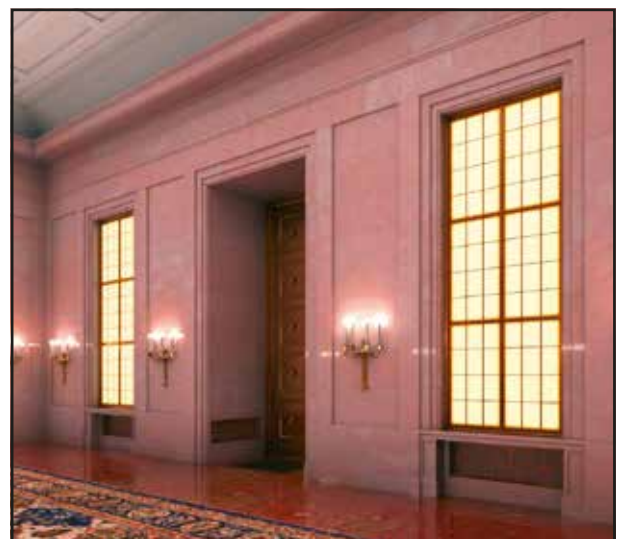
Fig. 44 The east wall with the two windows

The space between the windows of the Court of Honor and the Entrance Hall was approx. 2.3m deep. In order to prevent these deep window shafts from becoming visible, Albert Speer, like Leonard Gall before him, decided to install independent windows in the Entrance Hall. In this way he ensured that the very deep window reveals could not be seen from either the Court of Honor or the Entrance Hall. However, due to the east wall being

more than 2 meters thick, it also meant that no direct light could reach the Entrance Hall through the window openings. This was not only due to the thickness of the wall, but also to the depth of the portal in the Court of Honor. Considering that these two windows were the only source of natural light for the room, one can assume that without the use of additional artificial lighting, the Entrance Hall would have been extremely dark.

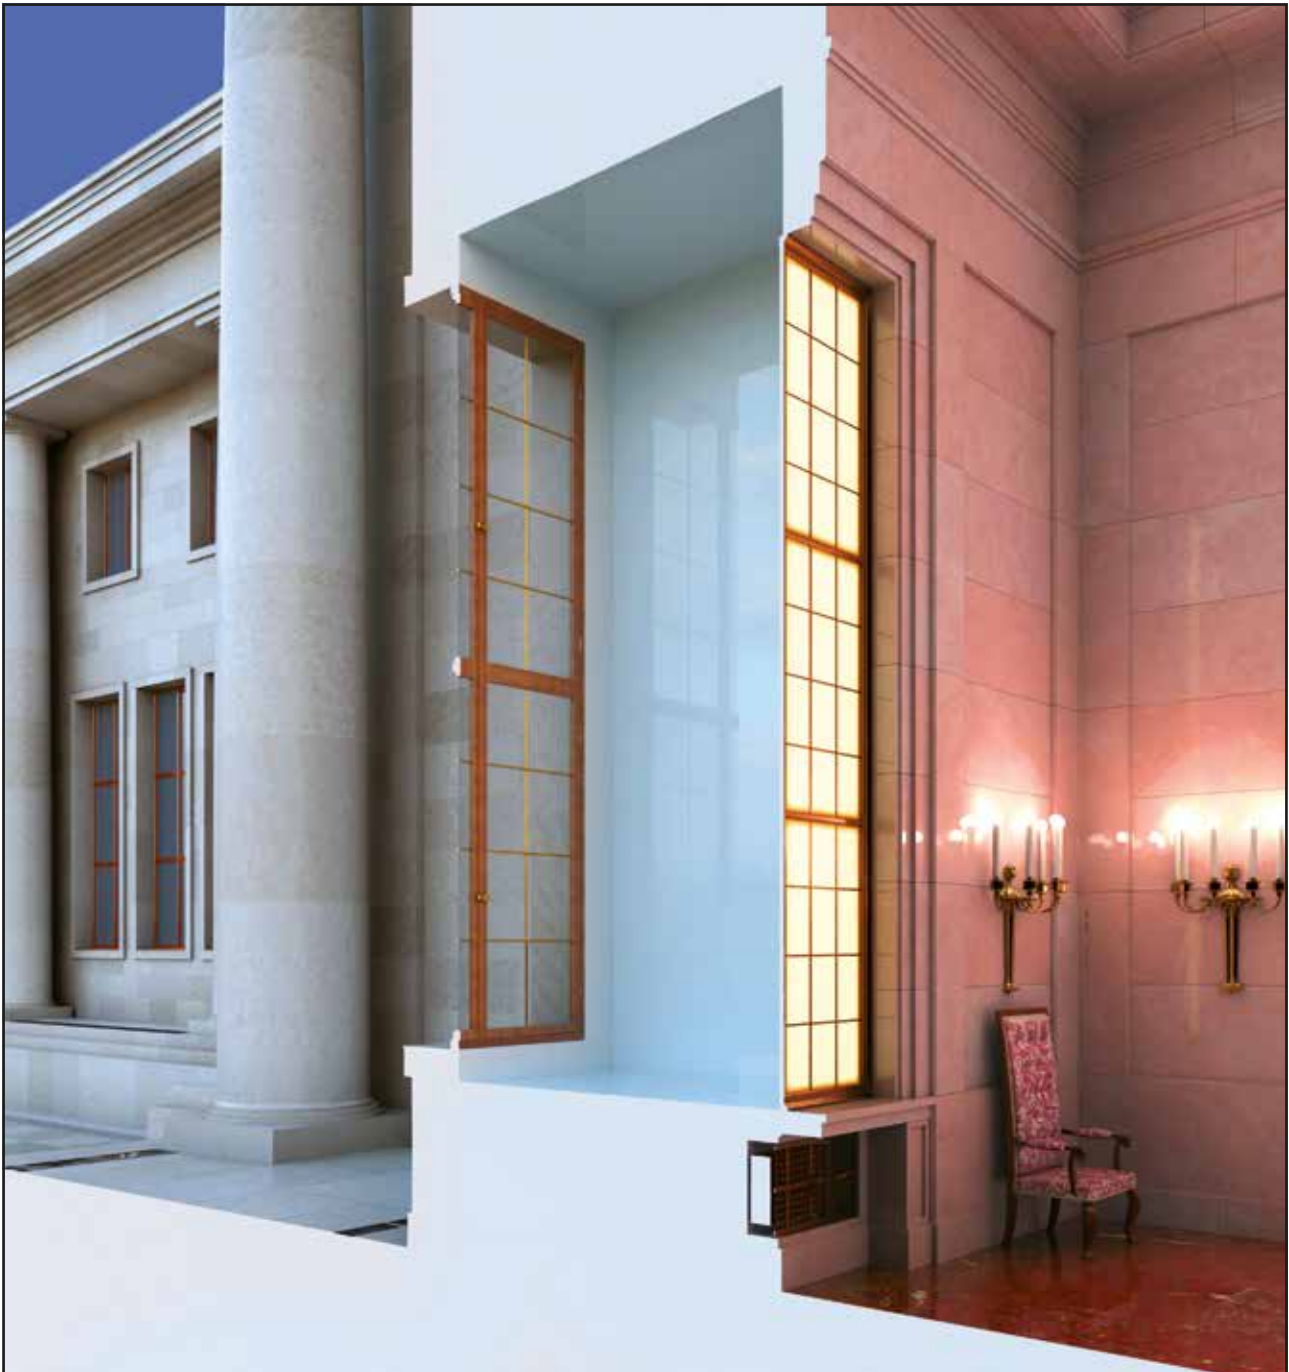
Fig. 55 Section through the window shaft - inside and outside windows were approx. 2.3m apart

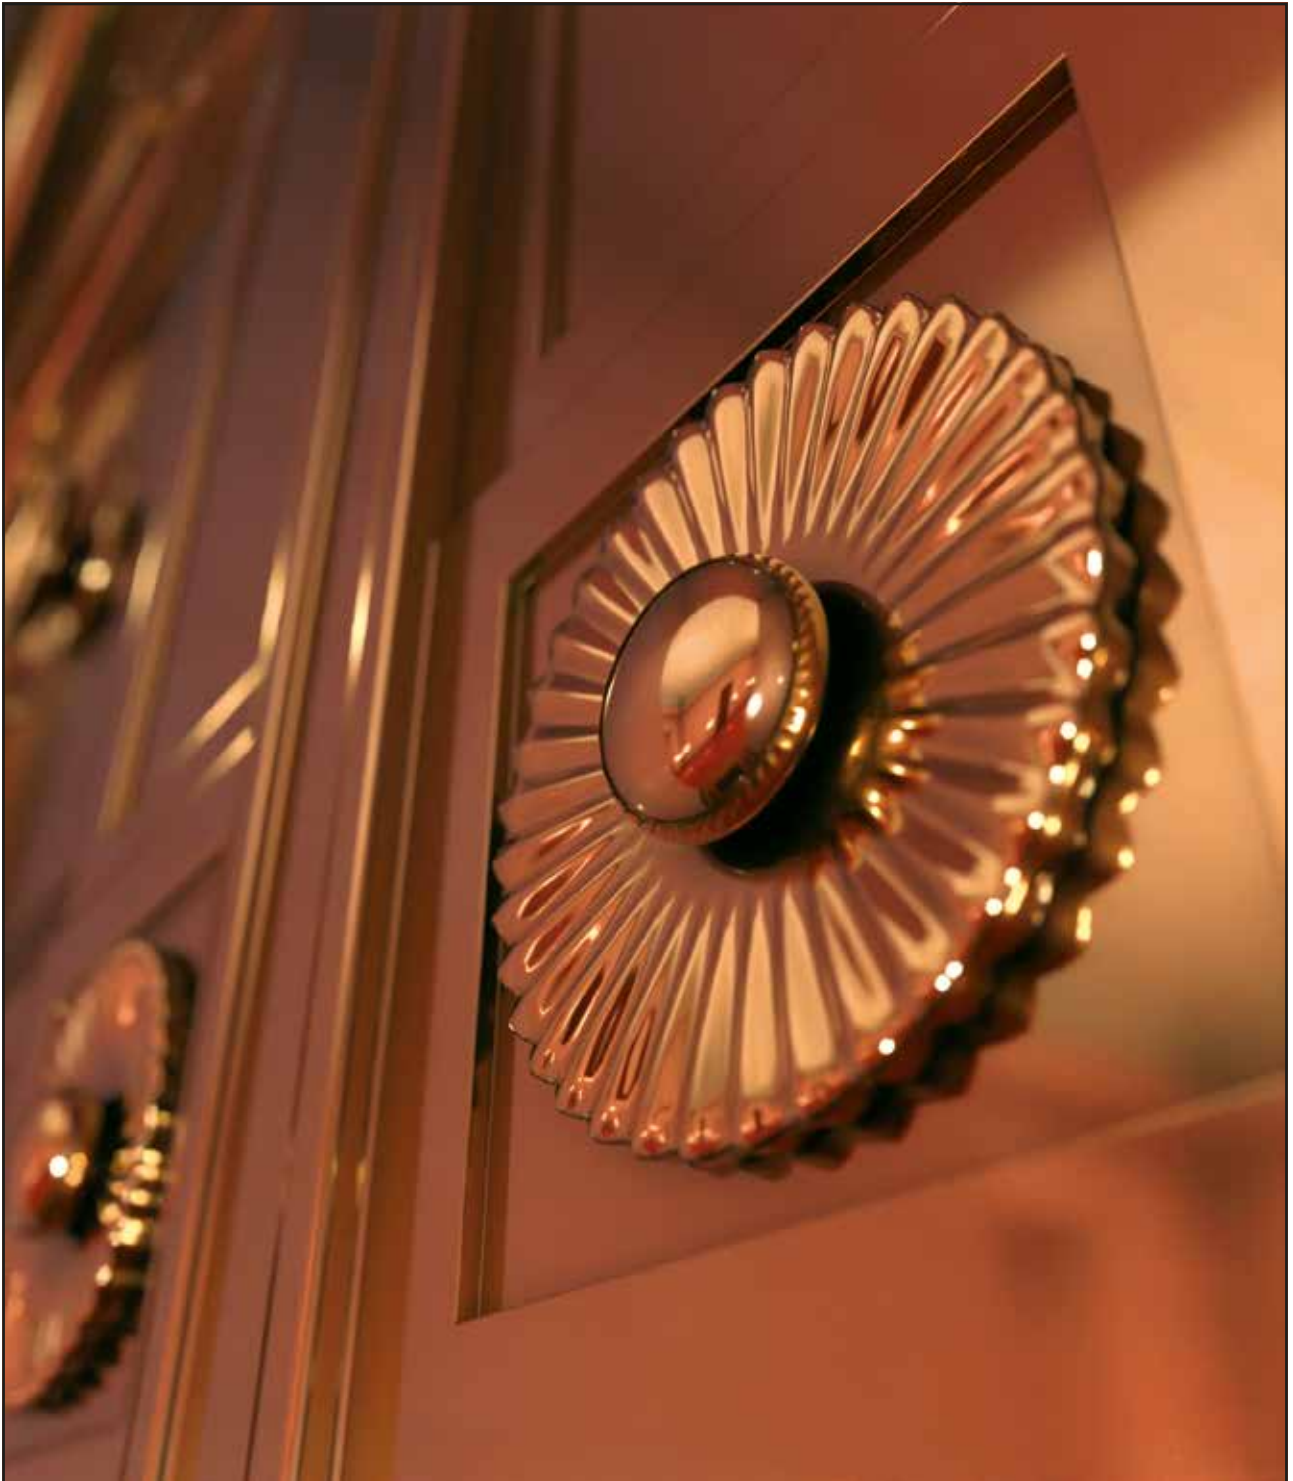
Fig. 65 Detailed view of one of the floral ornaments on the intersection of the bands

But despite the obvious presentation of power at this point, Albert Speer still designed the door with a level of attention to detail that placed the greatest emphasis on the overall aesthetic appeal. In the door to the Entrance Hall he varied the basic design principles that he also used in the designs of the outer doors of the New Reich

Chancellery. The Entrance Hall, however, was a festive space. Therefore, Speer replaced the rivet heads that were otherwise attached to the outer doors at the hinge crossing points on this door with detailed floral ornaments. The demonstration of power in this door dissolved almost unnoticed in the architect's attention to detail.

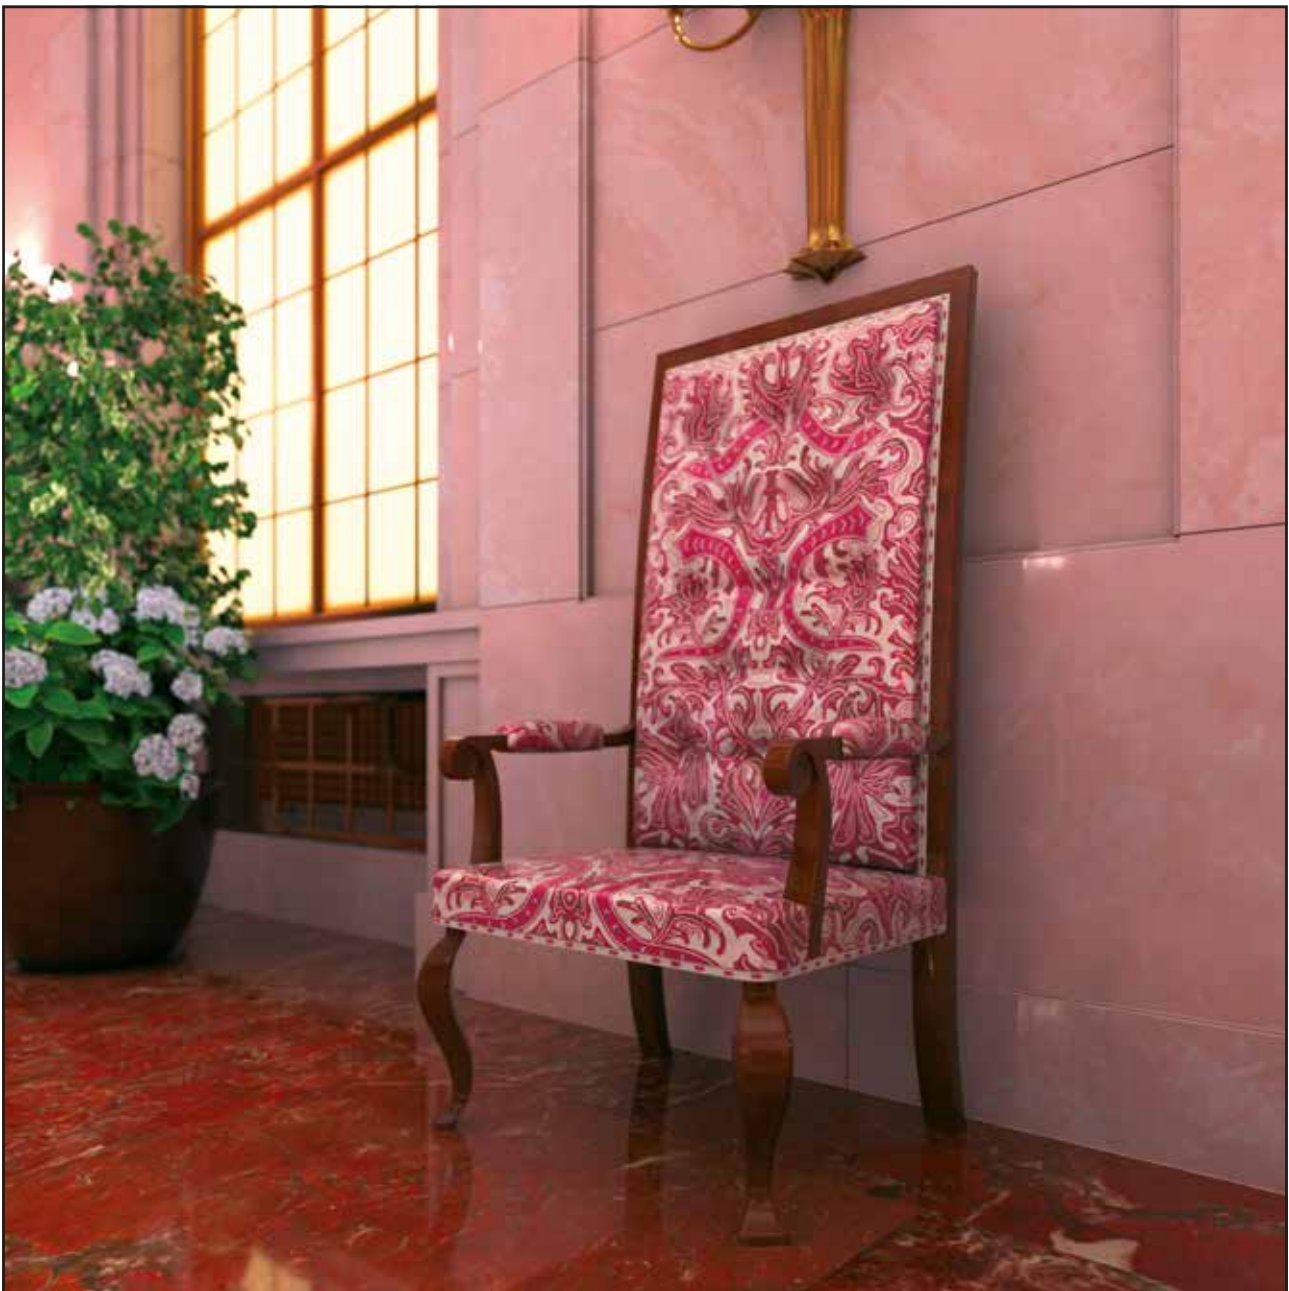
Fig. 85 The chairs, placed strictly in the mirrored surfaces of the walls, had a purely optical function.

In terms of design language, the chairs corresponded to the wall tables. Albert Speer designed the front chair legs in the same basic shape as he designed

the legs of the wall tables. Speer had the seats and armrest padding of the chairs covered in pink brocade. The covering had an ornamental floral motif and was therefore visually related in shape and color to the flower-shaped inlays on the drawers of the wall tables and the pink of the marble on the walls. The floral ornamentation of the seat covers was also in direct dialogue with the floral decorations on the plant bowls that were set up during social events and were firmly integrated into the design of the Entrance Hall.

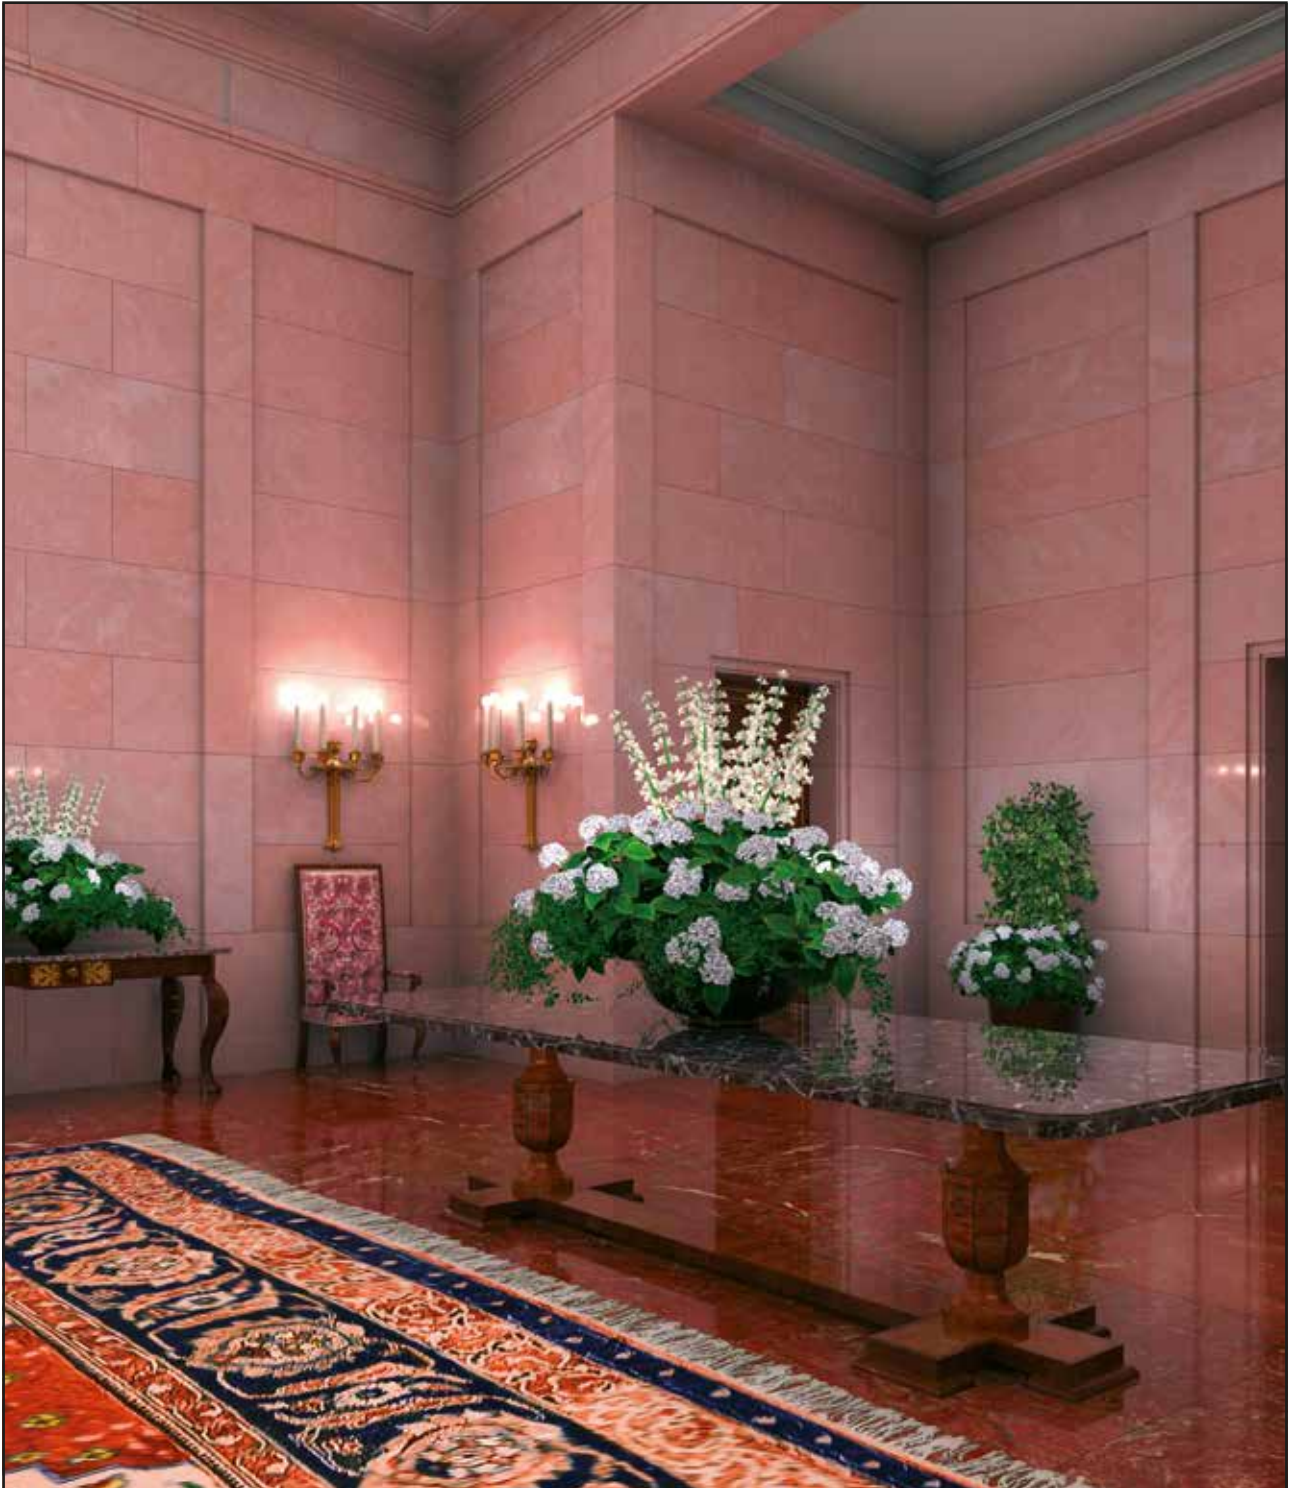
Fig. 87 The floral decoration was used to specifically support the architectural effect of the Entrance Hall.

Albert Speer designed a long rectangular table for the position on the northern wall of the Entrance Hall. The frame of the table was made of a solid wooden frame on which a marble top rested. The table had a fixed, prescribed place in the Entrance Hall because it not only served as a place where the flower bowls could be placed during so-

cial events. The main function of the table was to visually separate the small hall in the floor area from the Entrance Hall. It was positioned at the transition between the Entrance Hall and the small hall because it served as a room divider and thereby reinforced the visual demarcation between the Entrance Hall and the small hall.

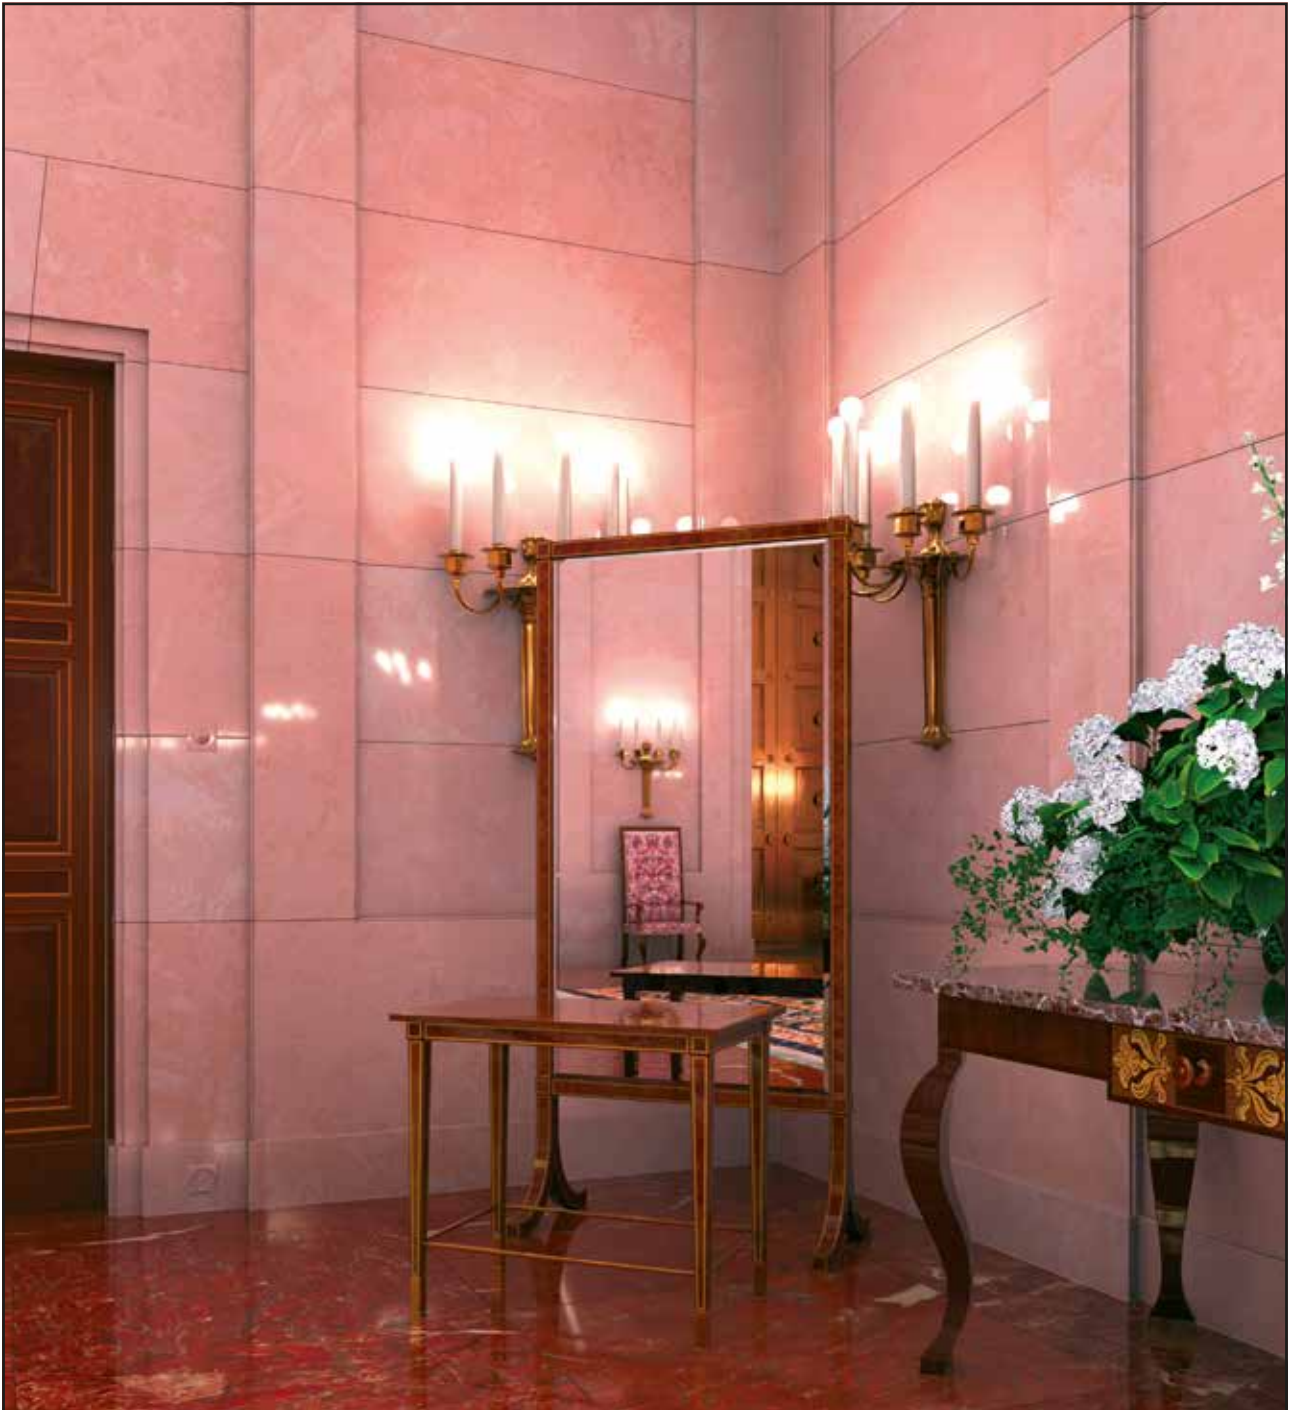
Fig. 95 The southwest corner of the Entrance Hall with the wardrobe furniture that was later installed here

One set of furniture stood out from the overall design of the Entrance Hall due to its design. However, this set can only be seen in a later photo of the Entrance Hall, this was a standing mirror with a small side table. It is interesting that in the construction drawings of the furniture in the dining room there is a drawing for a side table that is very similar to the table in the Entrance Hall.

This table was apparently never set up in the dining room, as it cannot be seen in any of the surviving photos of the dining room. It can therefore be assumed that the table set up in the Entrance Hall came from the dining room. It was probably only later realized that at the receptions the ladies had to be given the opportunity to take a final look at their appearance after handing in their wardrobe.

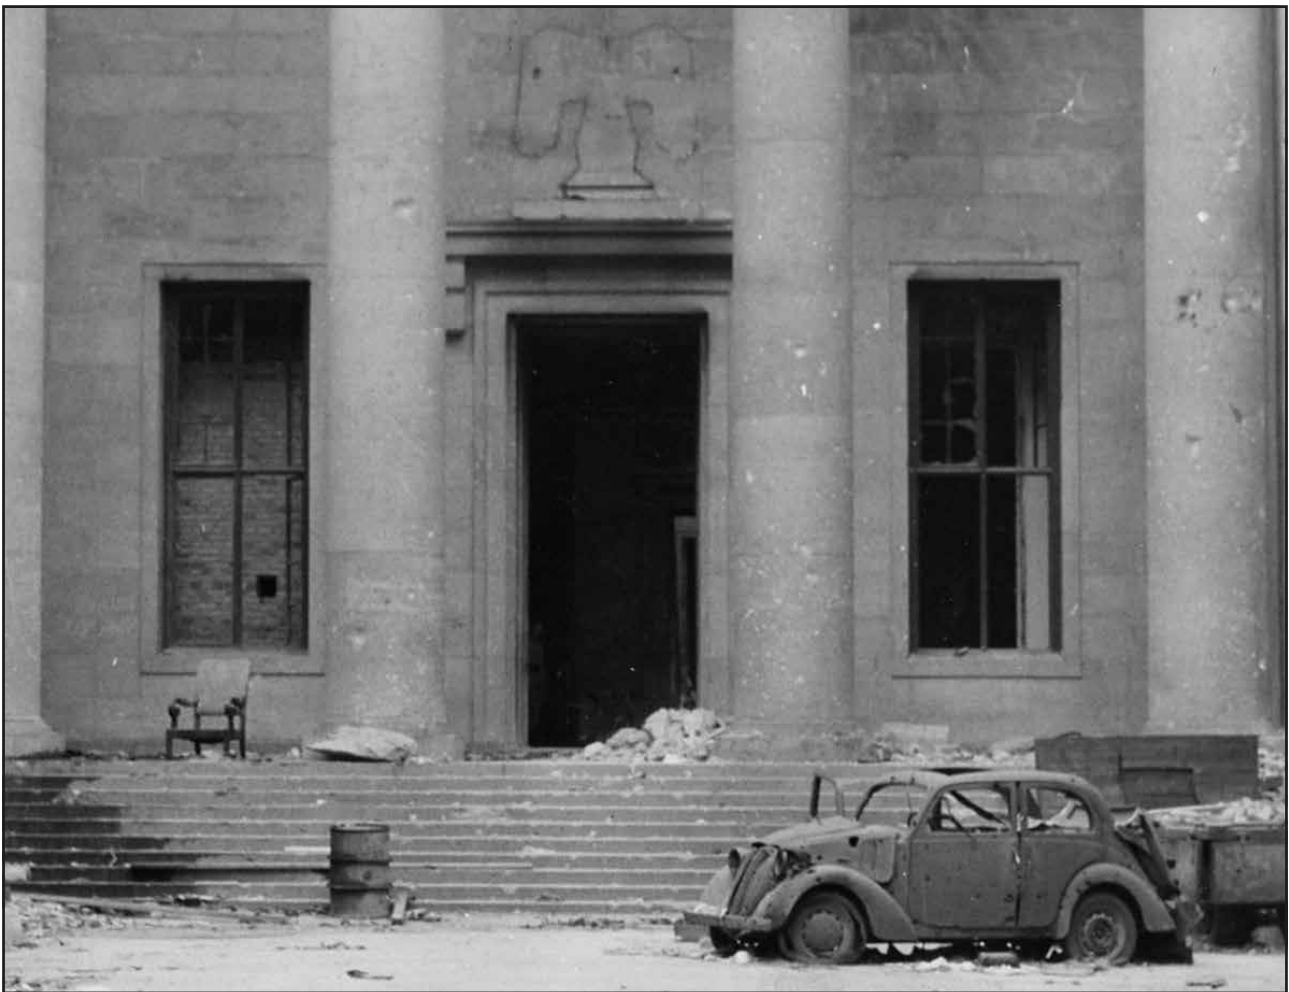
Fig. 109 Court of Honor (May 1945) / walled up window, removed door, missing inner bronze window

The Entrance Hall only had one outer wall with its east wall. This wall was also set back behind the portal of the courtyard. Above the Entrance Hall there were two further floors. Due to this relatively protected location, the Entrance Hall remained undamaged by bombs and artillery during the Battle of Berlin.

The whereabouts of the inner windows, the bronze door, the chairs and the wall tables are also unclear. Since there are no photographs of the Entrance Hall tak-
